PERFORMANCE OF THERMAL CONTROL TAPE
IN THE PROTECTION OF COMPOSITE MATERIALS

Rachel R. Kamenetzky
Ann F. Whitaker
NASA Marshall Space Flight Center
MSFC, AL

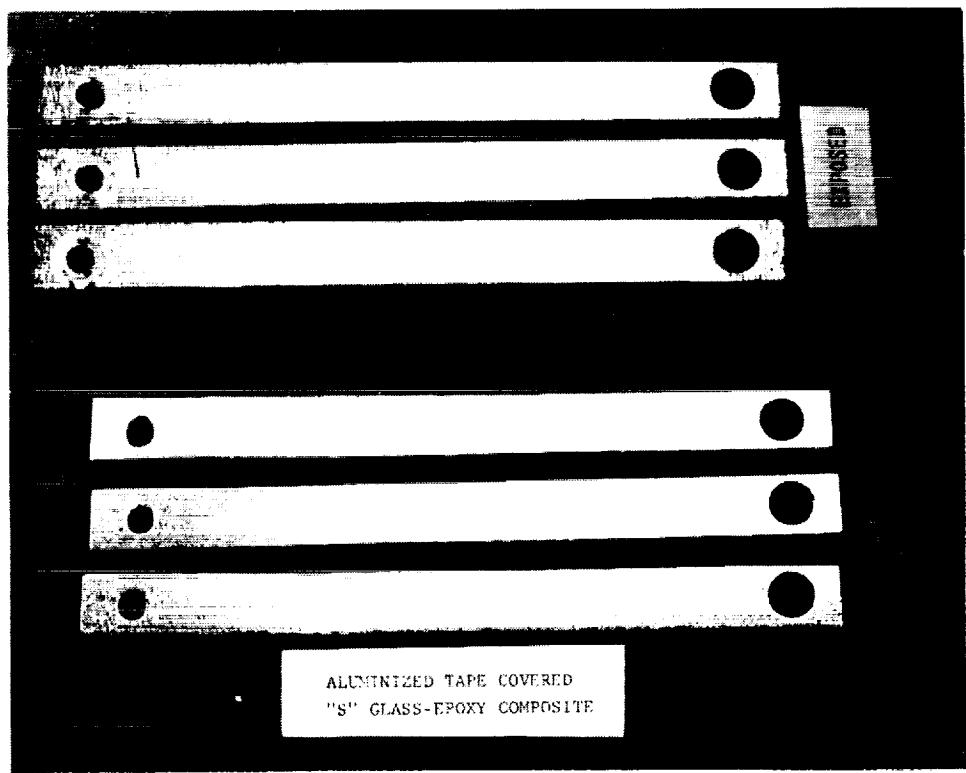
In order to evaluate the effects of the space environment on the aluminum thermal control tape, comparative series of visual and mechanical tests were performed on the tape covered flight composite samples and the laboratory tape covered control composite samples. As seen in figure 2 below, no clear visual distinction can be made between the flight exposed samples and the control samples. However, because the tape was applied only to the surface of the composites, the edges of the flight samples were exposed to atomic oxygen and UV radiation. The flight sample edges showed clear signs of resin erosion in the composite matrix. A thin oxide layer was also evident on both the exposed and control tape surface. Further work is needed to better quantify the thickness of this oxide layer.

Figure 2. Tape covered fiberglass epoxy composite flight and control specimens.

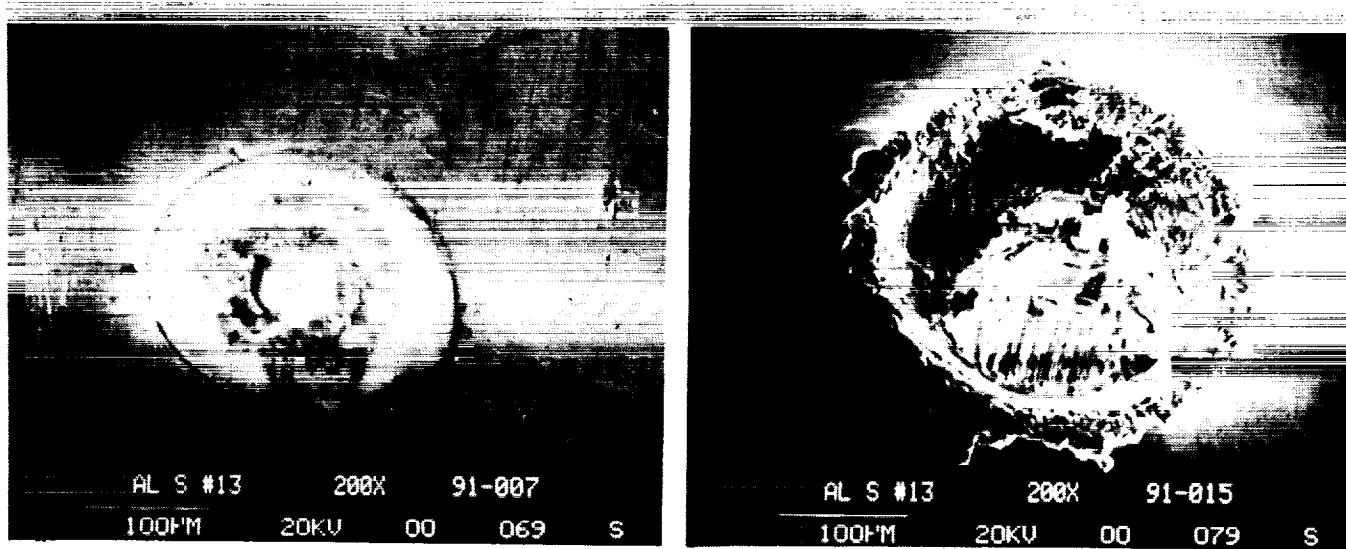
Two of the flight taped covered glass epoxy specimens showed evidence of a single impact with micrometeoroid/space debris, with each impact measuring less than 1mm in diameter. While the thermal control tape was able to prevent damage to the composite substrate on one flight sample, the impact on the second sample did penetrate through to the composite substrate causing damage to the underlying fibers. Figure 6 shown below is the SEM photographs of the impact area for the non-penetrating impact (left) and for the penetrating impact (right).

Figure 6. SEM photograph at 200x magnification of debris impacts on flight exposed tape covered fiberglass composites.
